**Northern California Project (January, 2001):**

Project Objective: to determine why Clarifier #5 generally fails before Clarifier #4.

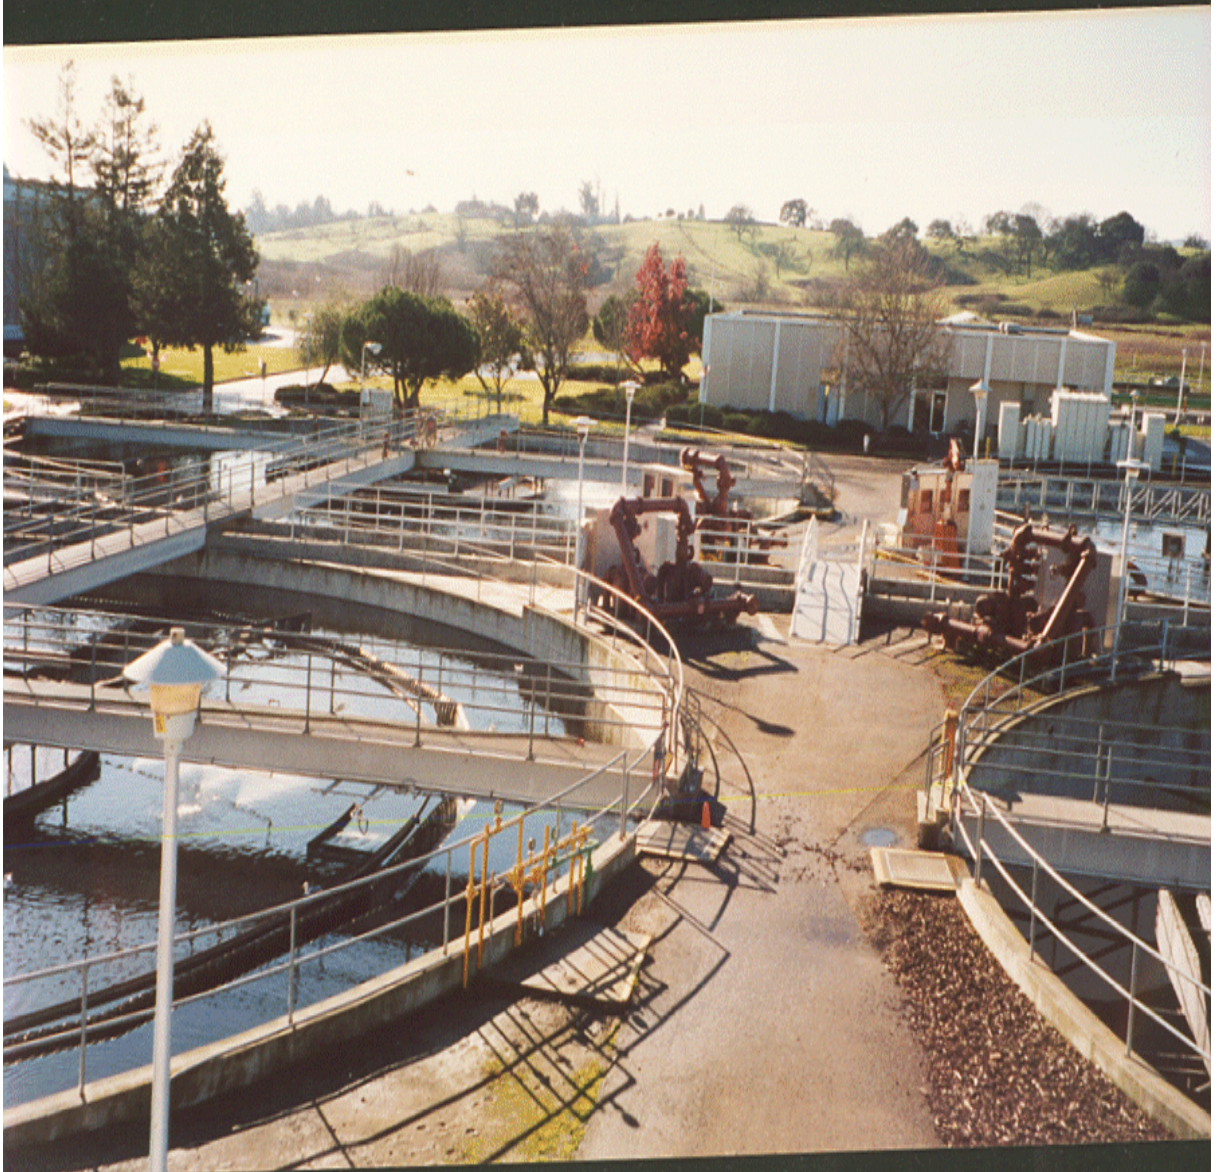
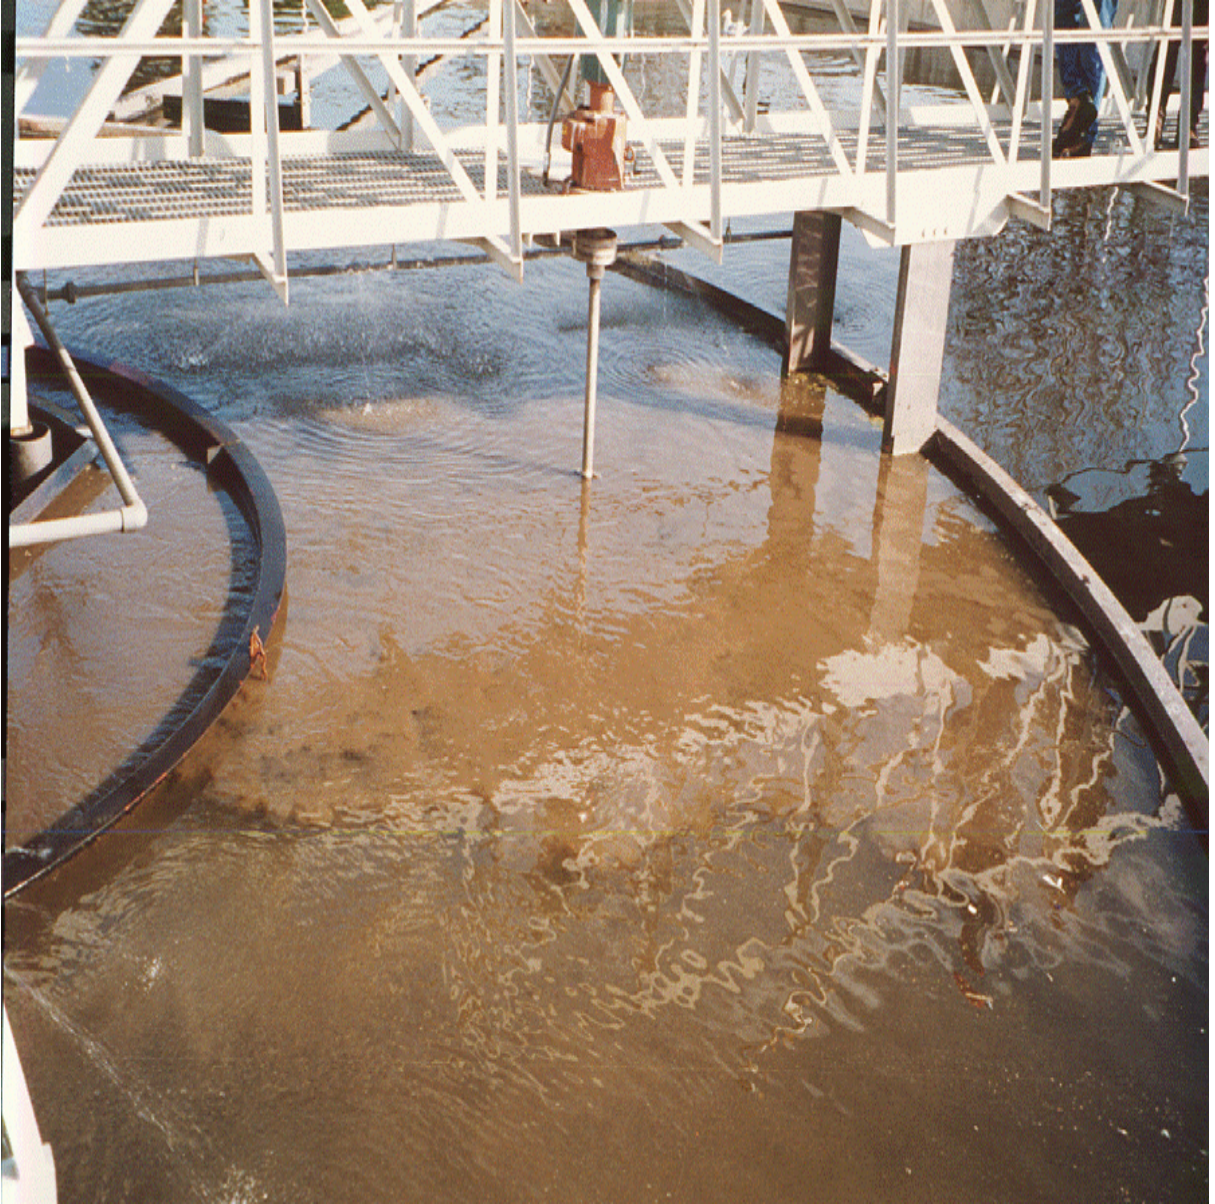
Observations: The two clarifiers were tested side by side at 9 mgd (870g/sf/d), 12 mgd (1160 g/sf/d), and 15 mgd (1450 g/sf/d). At 15 mgd, the sludge blanket level in #5 increased significantly and the effluent TSS increased from 8 mg/l to 15 mg/l. Both the sludge blanket and the ETSS in #5 were trending upward when the test ended. The conditions in #4 were stable.

During the last test, it was discovered that the 18' diameter energy-dissipating inlet (EDI) in #4 had no bottom! This is contrary to normal design practice. The EDI is supposed to be a "tub" which forces the flow out tangentially into the centerwell.

Conclusion: The EDI with no bottom created better hydraulic conditions in Clarifier #4 than did the standard, scooped EDI in Clarifier #5
