## **Western Pennsylvania Project (June, 2001):**

Plant Capacity: 20 mgd

No. of Clarifiers: #1-#6 .... 103' diam (octagons); #7-#10 ....108' diam. RimFlo

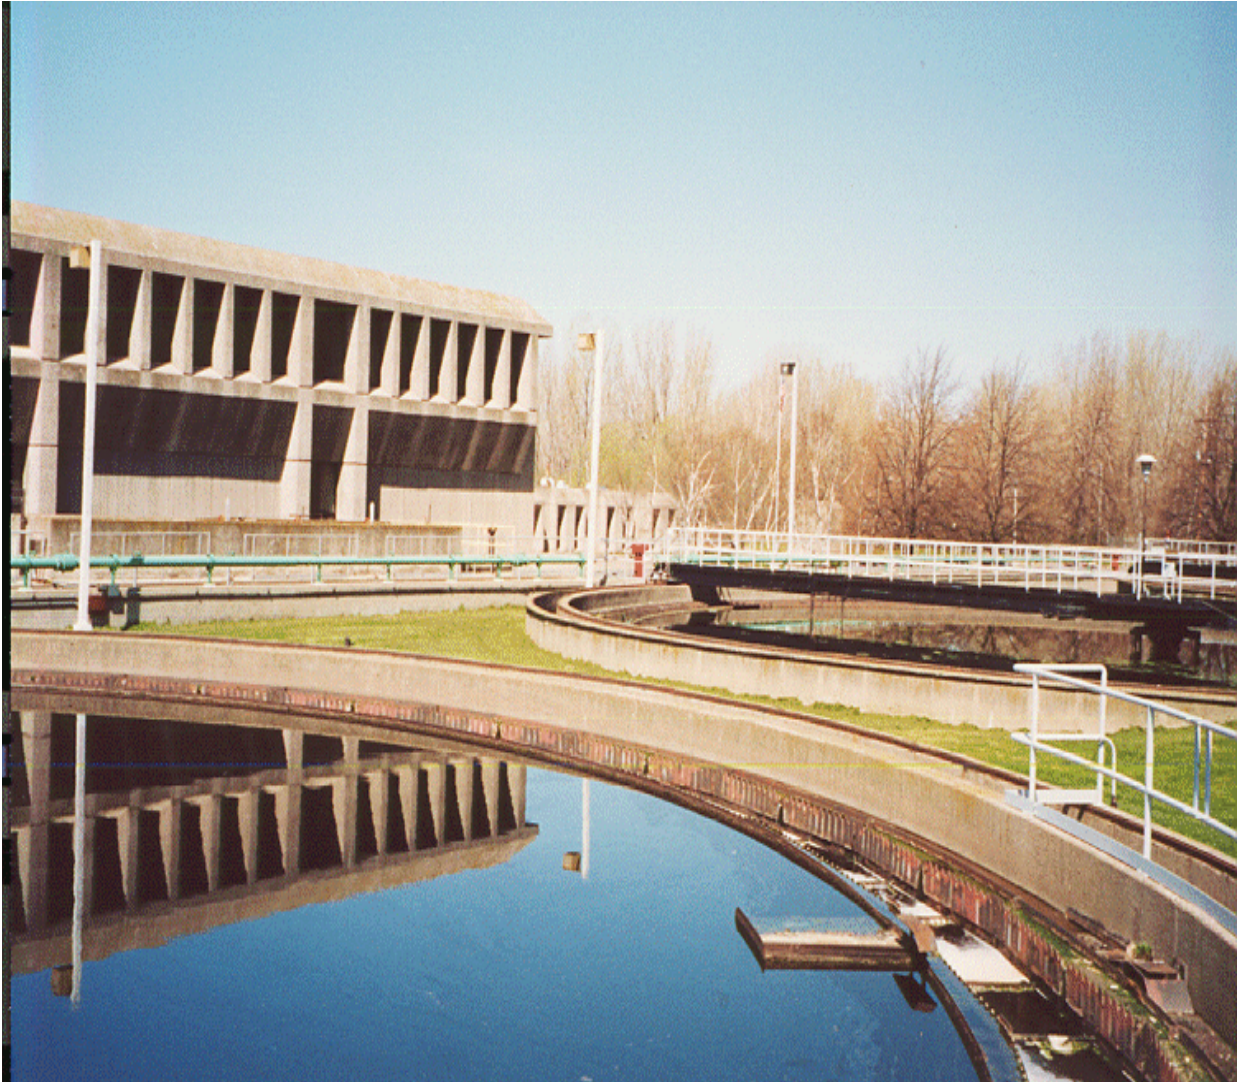
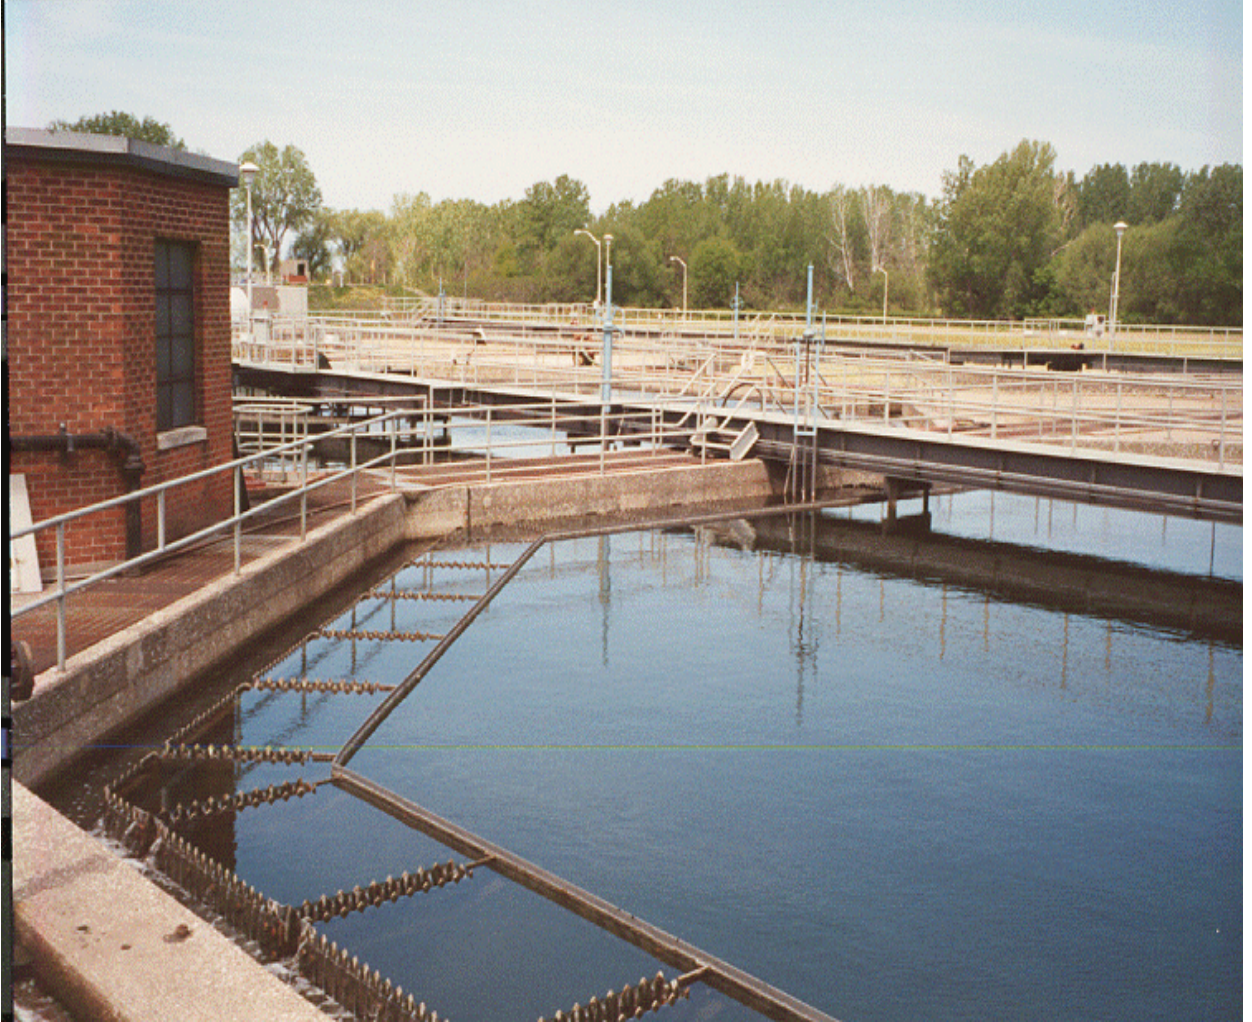
Observations: The octagonal clarifiers had strong short-circuiting currents at the floor, in the range of 7 to 9 fpm. Blankets were unable to form, especially in the centerwell area. The peripheral feed clarifiers performed as designed, with currents in the range of 4 fpm at the bottom towards the center, and reverse currents at the surface from the center towards the peripheral launder. Blankets in the RimFlo clarifiers were maintained routinely 3 to 5 feet deep by the operating staff in order to thicken the stored sludge solids prior to wasting.

Conclusions: Modify Clarifiers #1-#6 by adding a new centerwell, changing the effluent launders to a standard circumferential shape, and adding a Crosby cylindrical baffle. We also recommended that the client consider totally reconstructing these clarifiers in view of the number of performance-limiting design conditions that would still remain. (Note: It is unusual for us to recommend a reconstruction of a clarifier. Generally, a clarifier can be improved by implementing simple modifications and control strategies.)
